**EASTLAKE SLOPE P-PATCH AND HILL CLIMB**

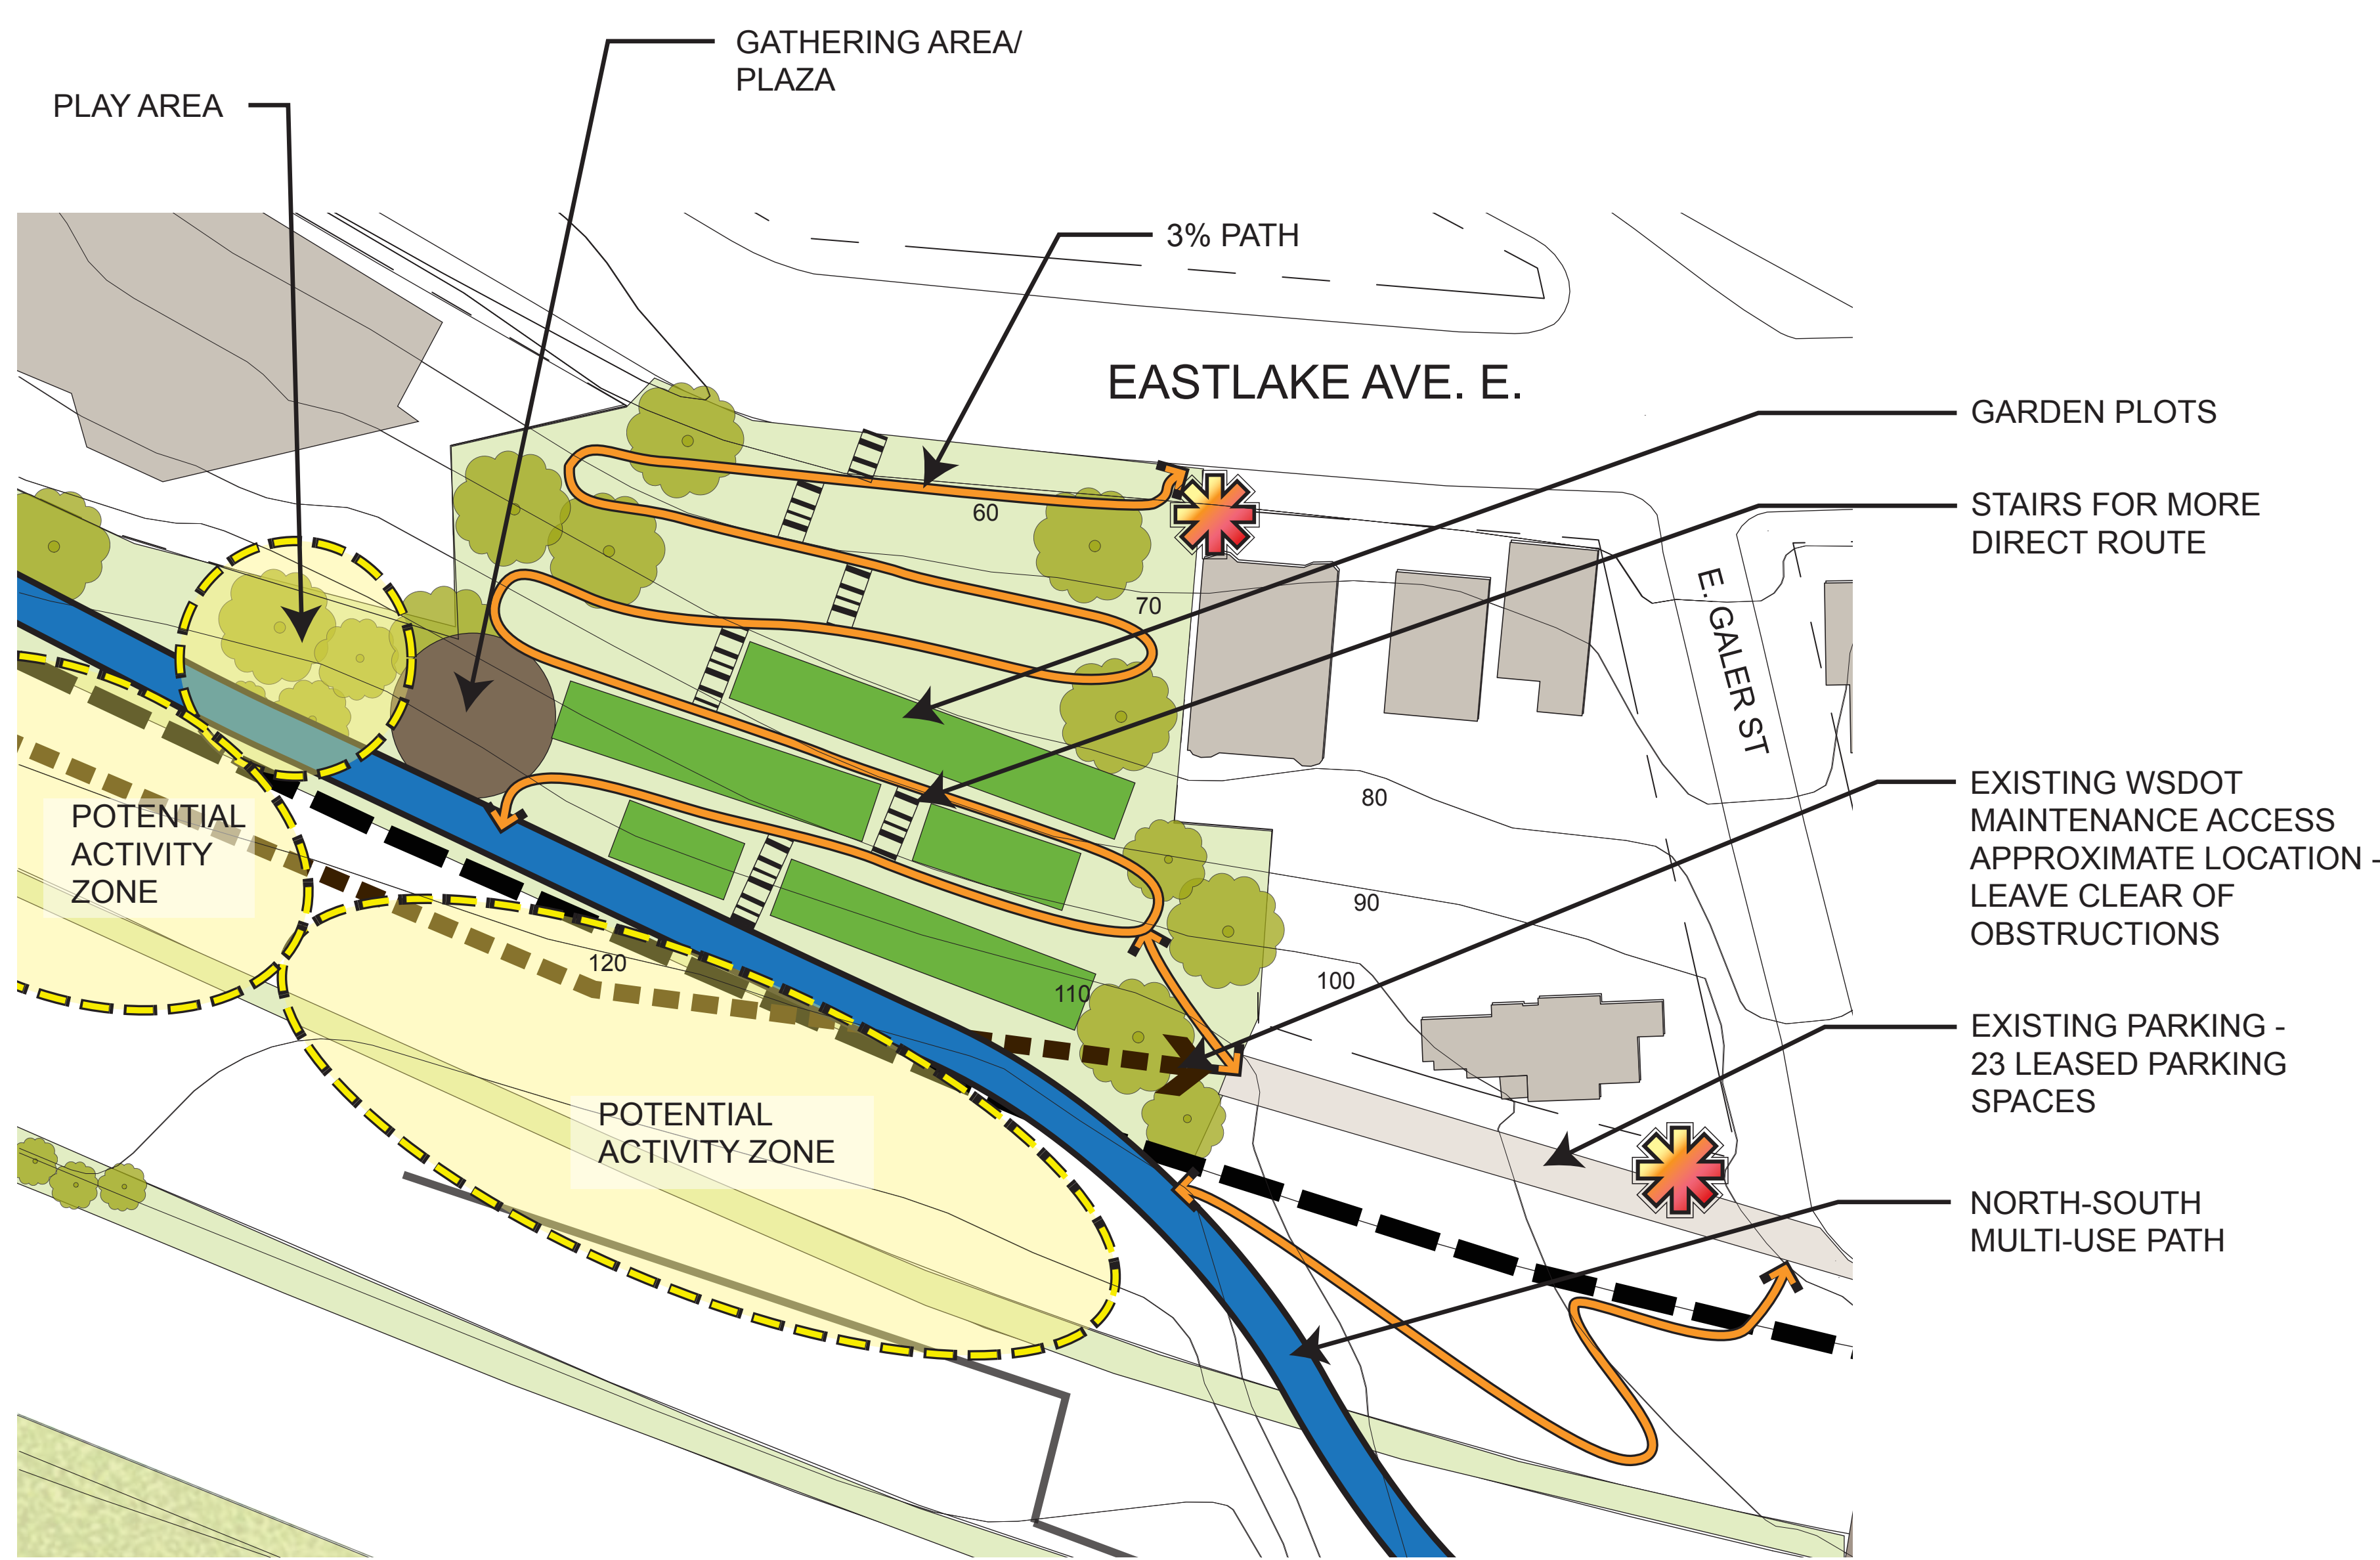
- EXISTING PEDESTRIAN CONNECTION
- NORTH-SOUTH MULTI-USE PATH  
MAX SLOPE 5%
- PEDESTRIAN PATH
- STAIRS
- EXISTING GABION WALLS
- FREEWAY ABOVE
- EXISTING WSDOT MAINTENANCE ACCESS ROAD
- ACTIVITY ZONE
- ENTRY GATEWAY

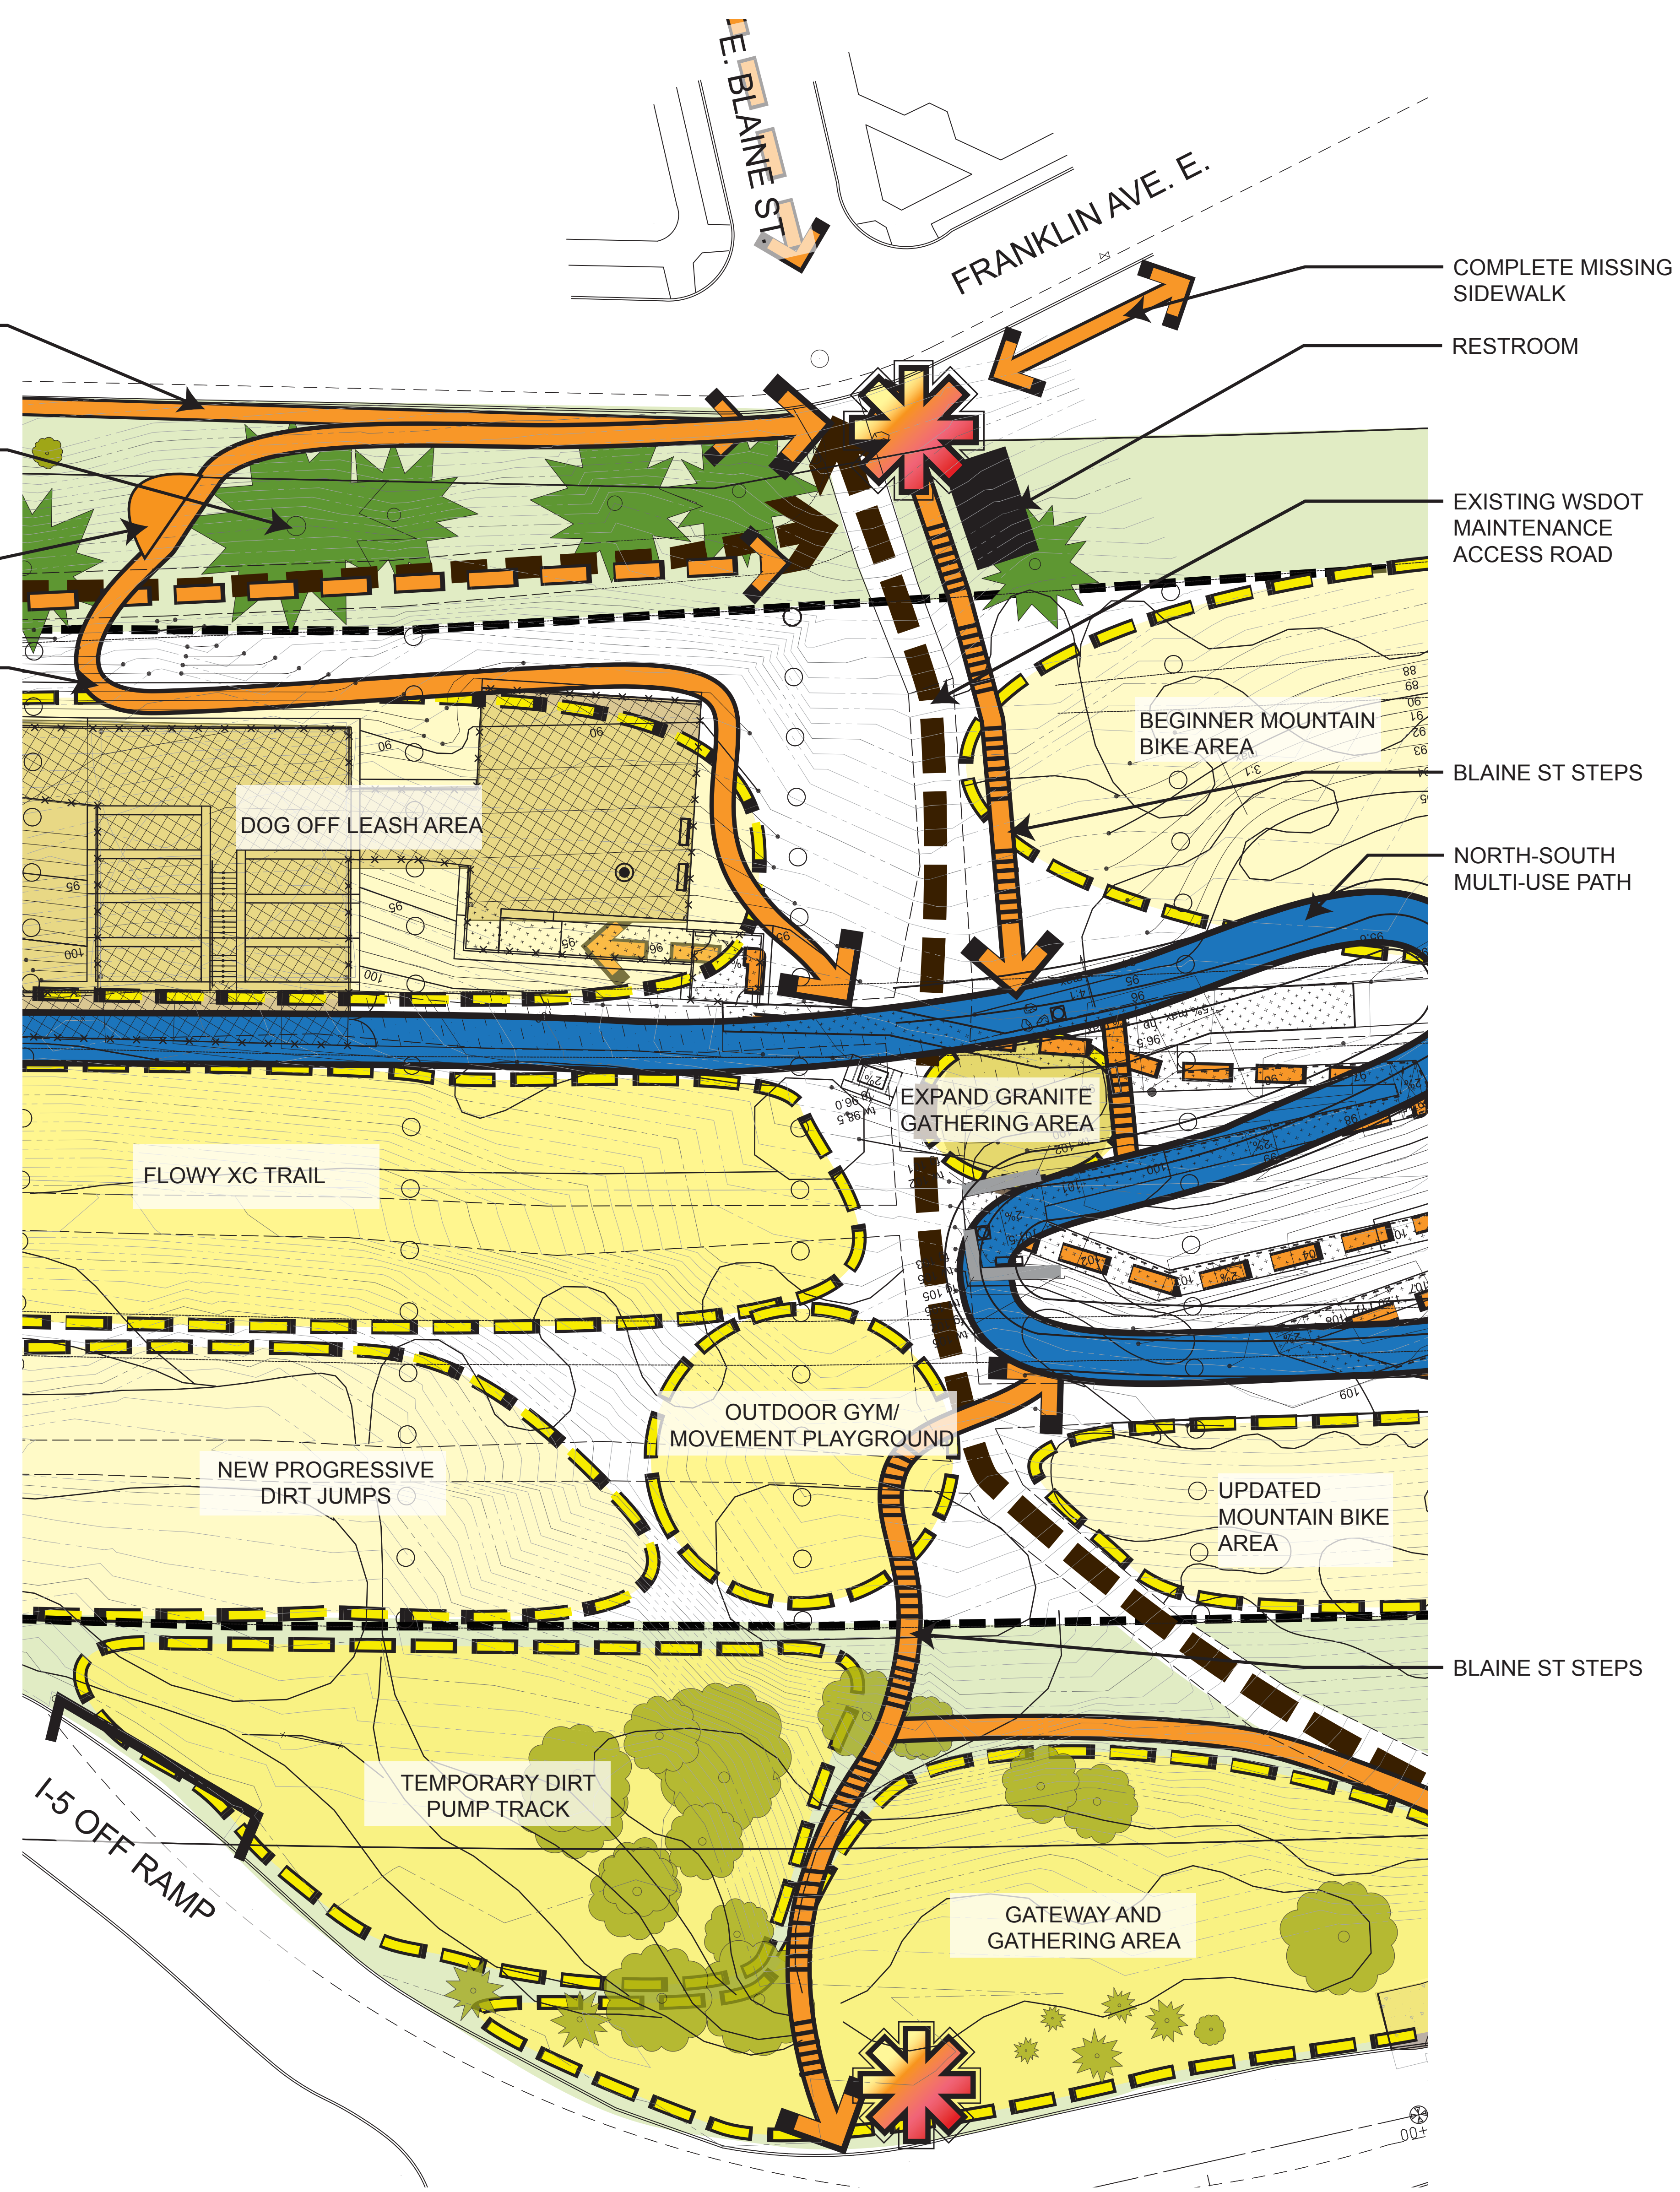
**E BLAINE ST ALIGNMENT**

- COMPLETE MISSING SIDEWALK
- REMOVE INVASIVE SPECIES AND DECIDUOUS TREES UNDERNEATH REDWOOD TREES TO INCREASE VISIBILITY FROM THE STREET
- VIEWING DECK OPPORTUNITY UNDER REDWOODS
- 6% PATH FROM E. BLAINE ST. ENTRANCE TO N ENTRANCE TO OFF-LEASH AREA AND ON TO GRANITE GATHERING AREA

AN ON-THE-GROUND SURVEY AND ADDITIONAL ENGINEERING IS NEEDED TO DETERMINE EXACT ROUTING OF PATHS AND STAIRS AND TO MINIMIZE POSSIBLE IMPACTS ON OTHER PARK FEATURES.
